Tapia
 2530 Topanga Canyon Blvd., Topanga

Plot Plan

Subject: Limited Engineering Geologic Report
Evaluation of a Groundwater Test Hole
2530 Topanga Canyon Blvd.
Topanga, California

RE: 2530 N. TOPANGA CANYON BLVD., TOPANGA, CA 90290

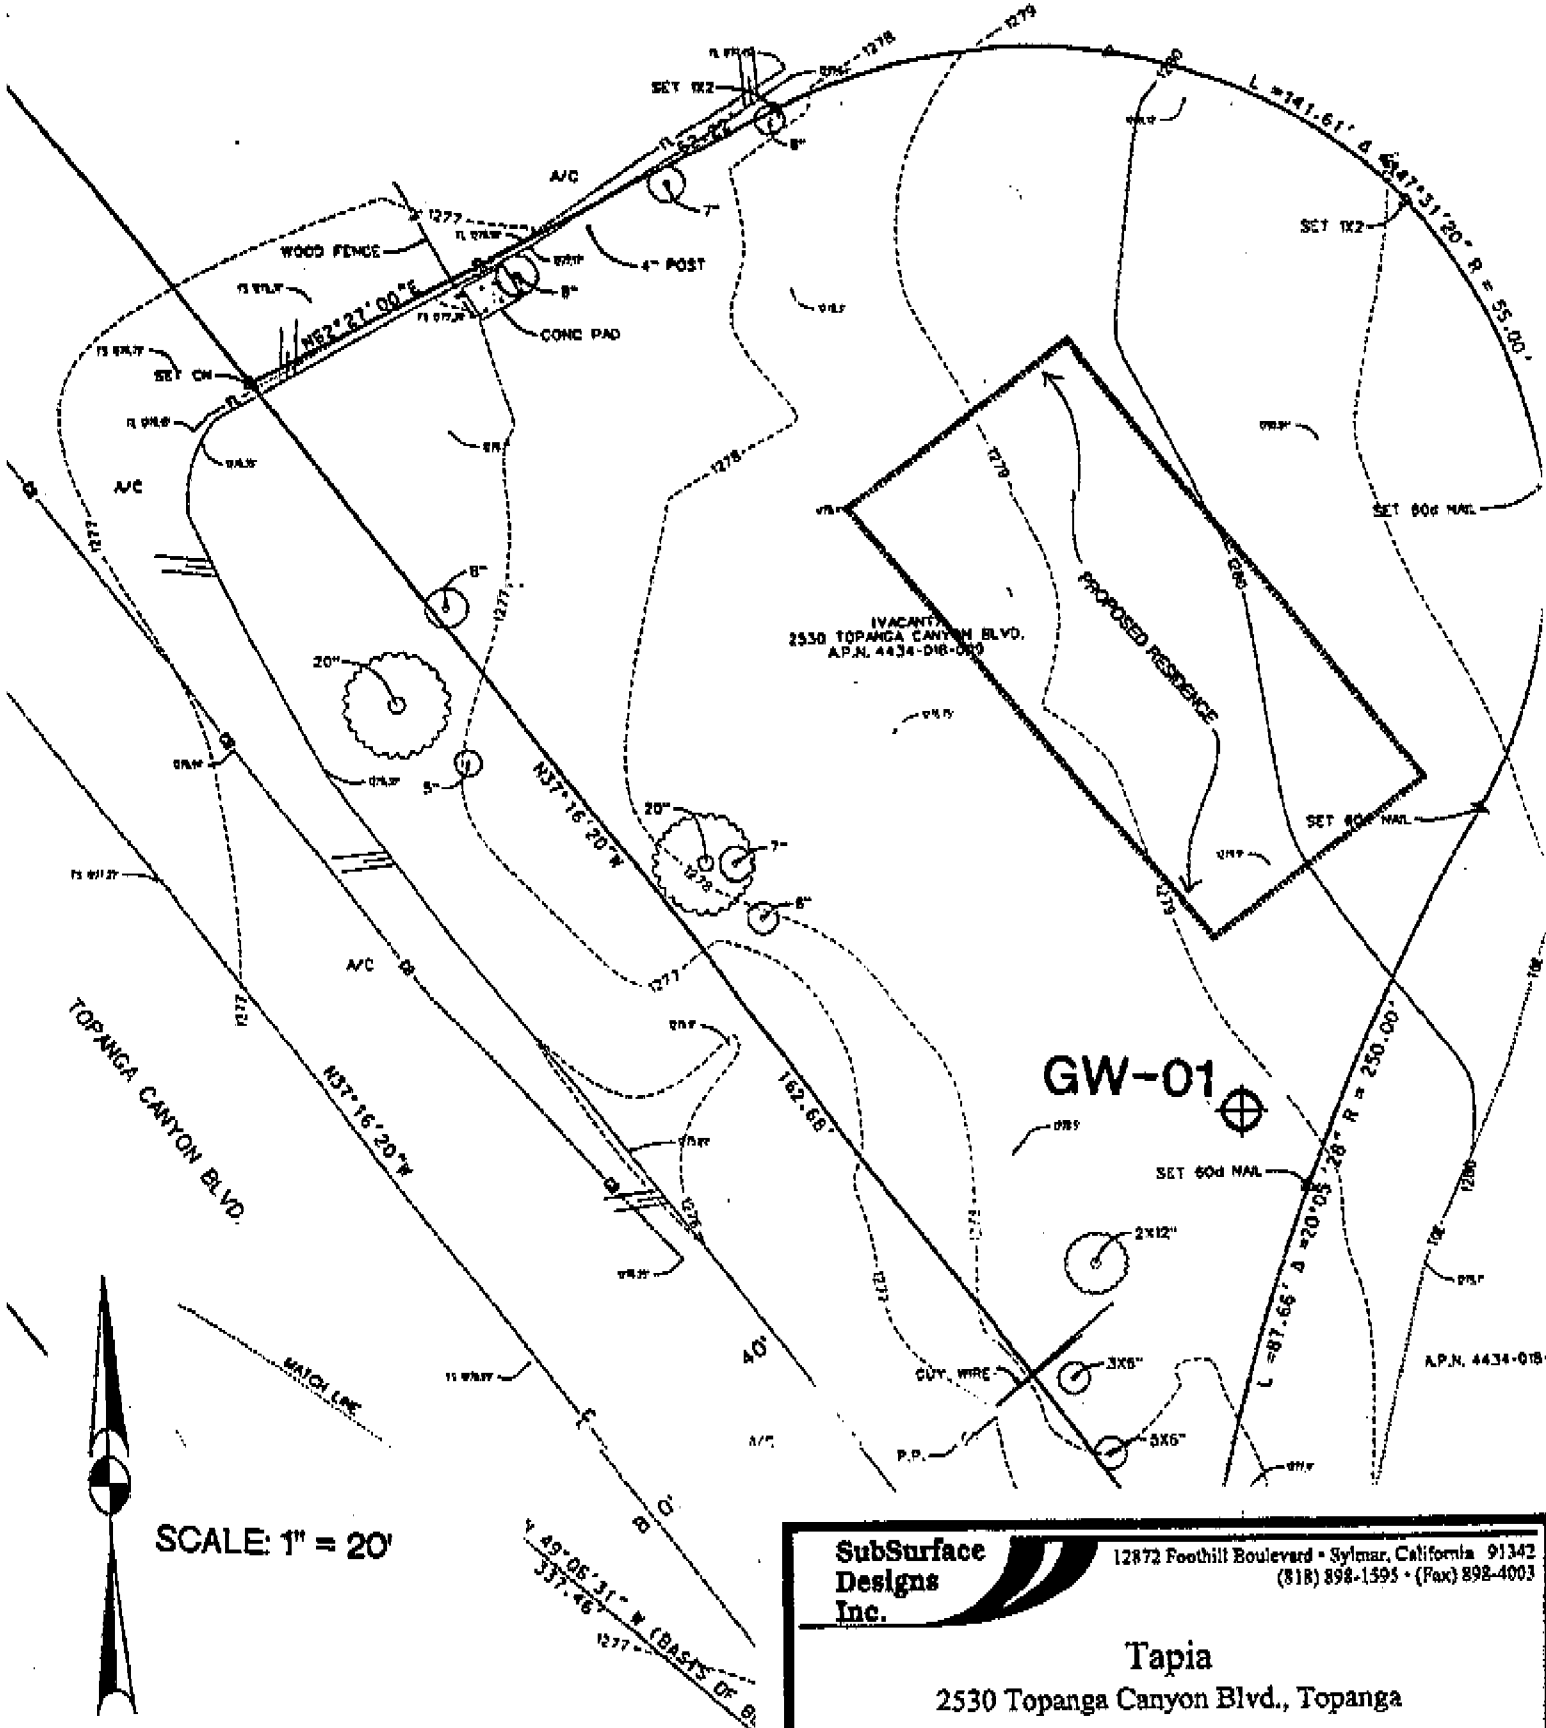
June 2004 Plate A

The groundwater test hole was excavated with a bucket-auger drill rig to depth of thirty-eight feet (38') on May 14, 2004. A representative from this office logged the open boring at this time. The test boring was reinspected by this office on May 19, 2004. Mr. Larry Young, Environmental Health Specialist, performed percolation testing on nearby test borings. For reference, a geologic log of the test hole has been prepared and is attached to this report. In addition, the location of the boring is shown on the attached Plot Plan.

The future seepage pit(s) shall be constructed in a similar location as the test hole. The pit(s) shall not exceed a total depth of twenty-seven feet (27'), and shall be capped a minimum of fifteen feet (15') below existing grade.
