Donald B. Kowalewsky
 ENVIRONMENTAL &
 ENGINEERING GEOLOGY

September 20, 2007
 revised October 4, 2007
 Job # 07630A1.001

SUBJECT: Geologic memorandum concerning observations, testing, and analyses of multiple vacant lots at 929 and 939 Fernwood Pacific Drive, Topanga, California

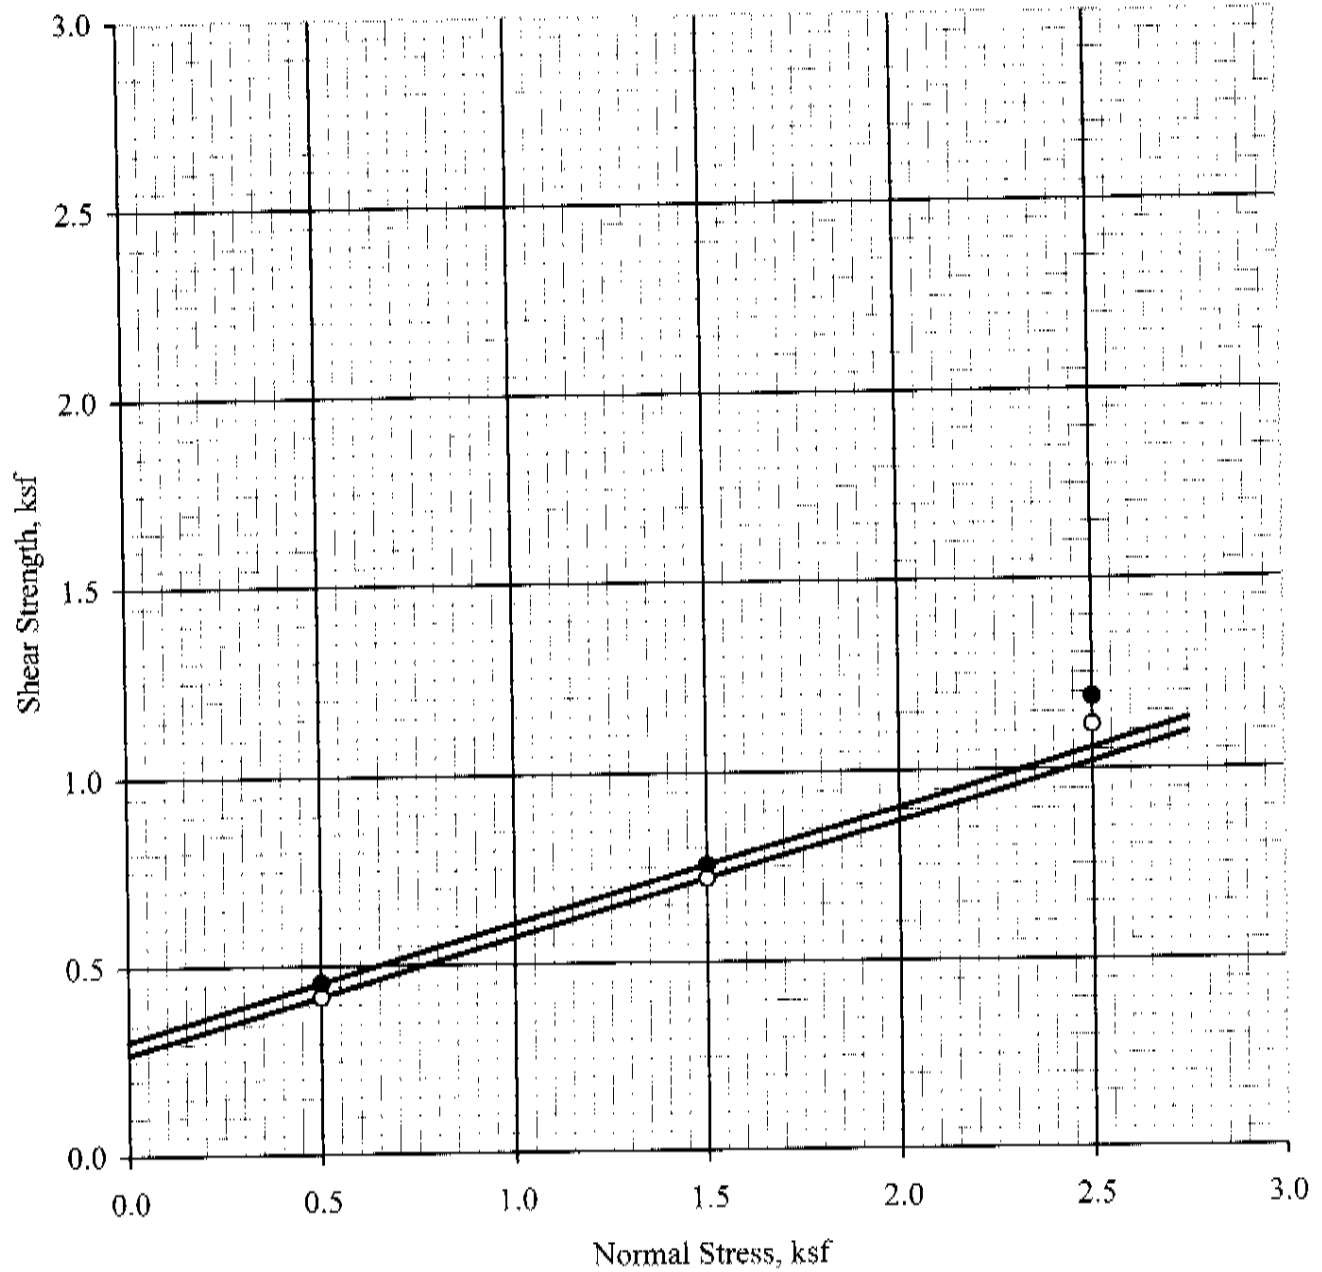
Shear Diagram

- Peak - At Saturation Moisture Content C = 300 psf $\phi = 16.5^\circ$
- Residual - At Saturation Moisture Content C = 270 psf $\phi = 16.5^\circ$

Boring : Onsite
 Depth : ---
 Description : Clayey seam
 (Sample 1)

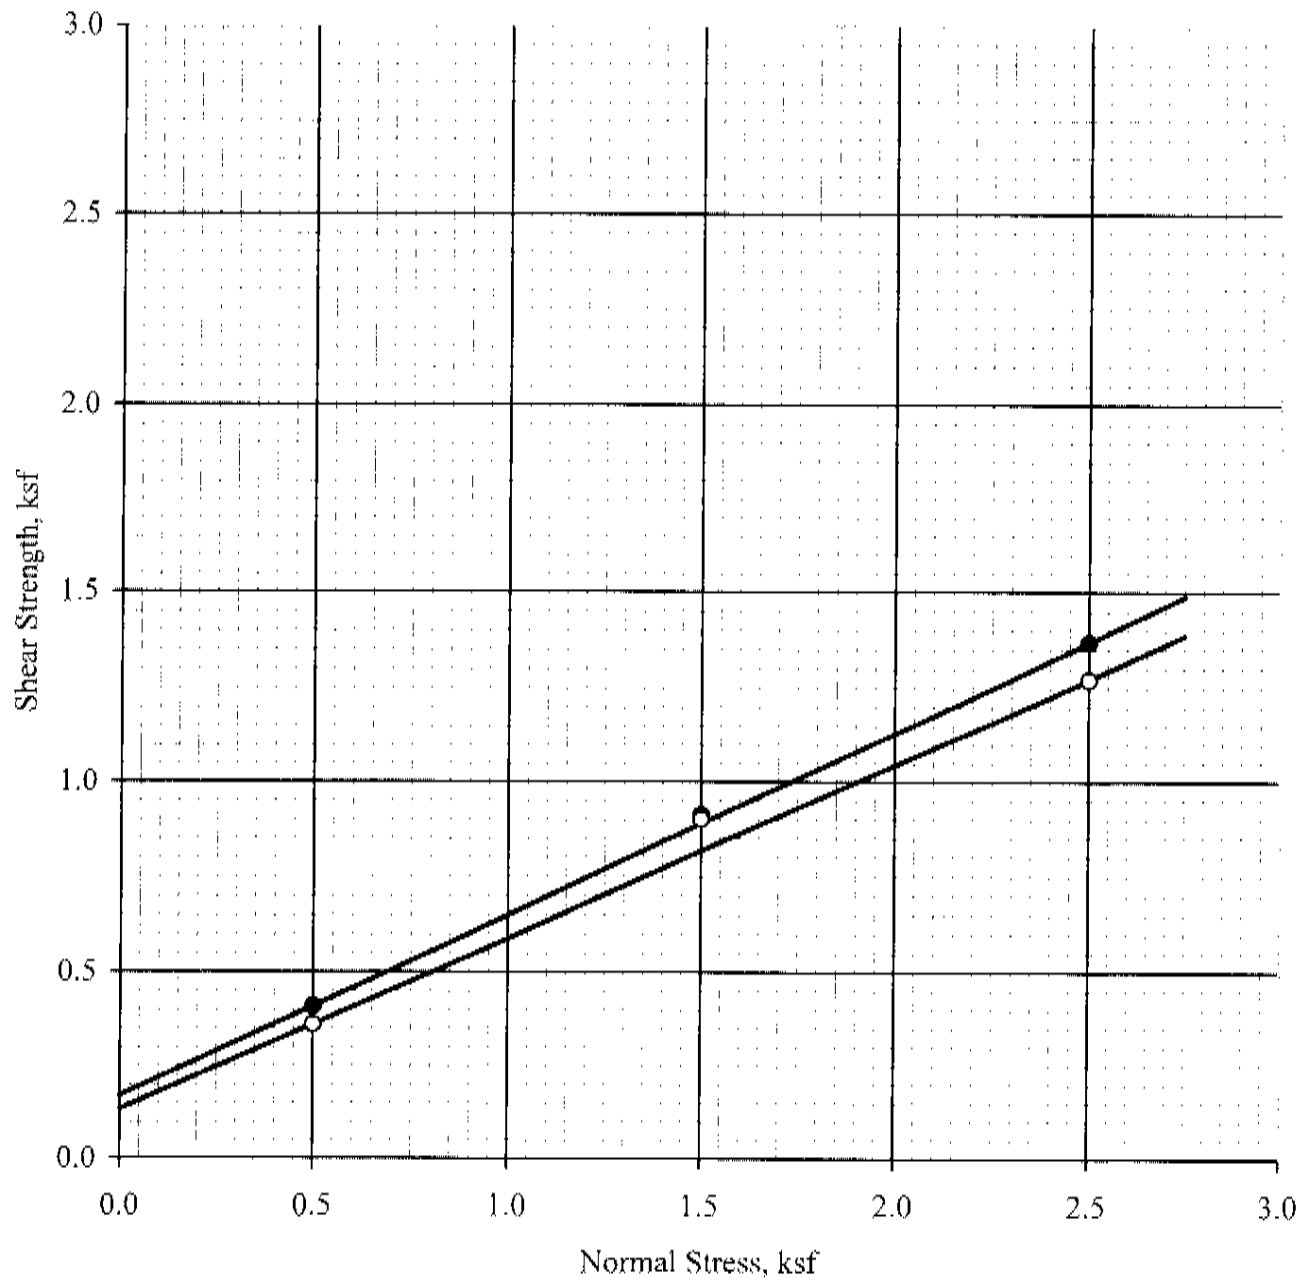
Shear Diagram

- Peak - At Saturation Moisture Content C = 160 psf $\phi = 25.5^\circ$
- Residual - At Saturation Moisture Content C = 130 psf $\phi = 24.5^\circ$

Boring : Onsite
 Depth : ---
 Description : Clayey seam
 (Sample 2)

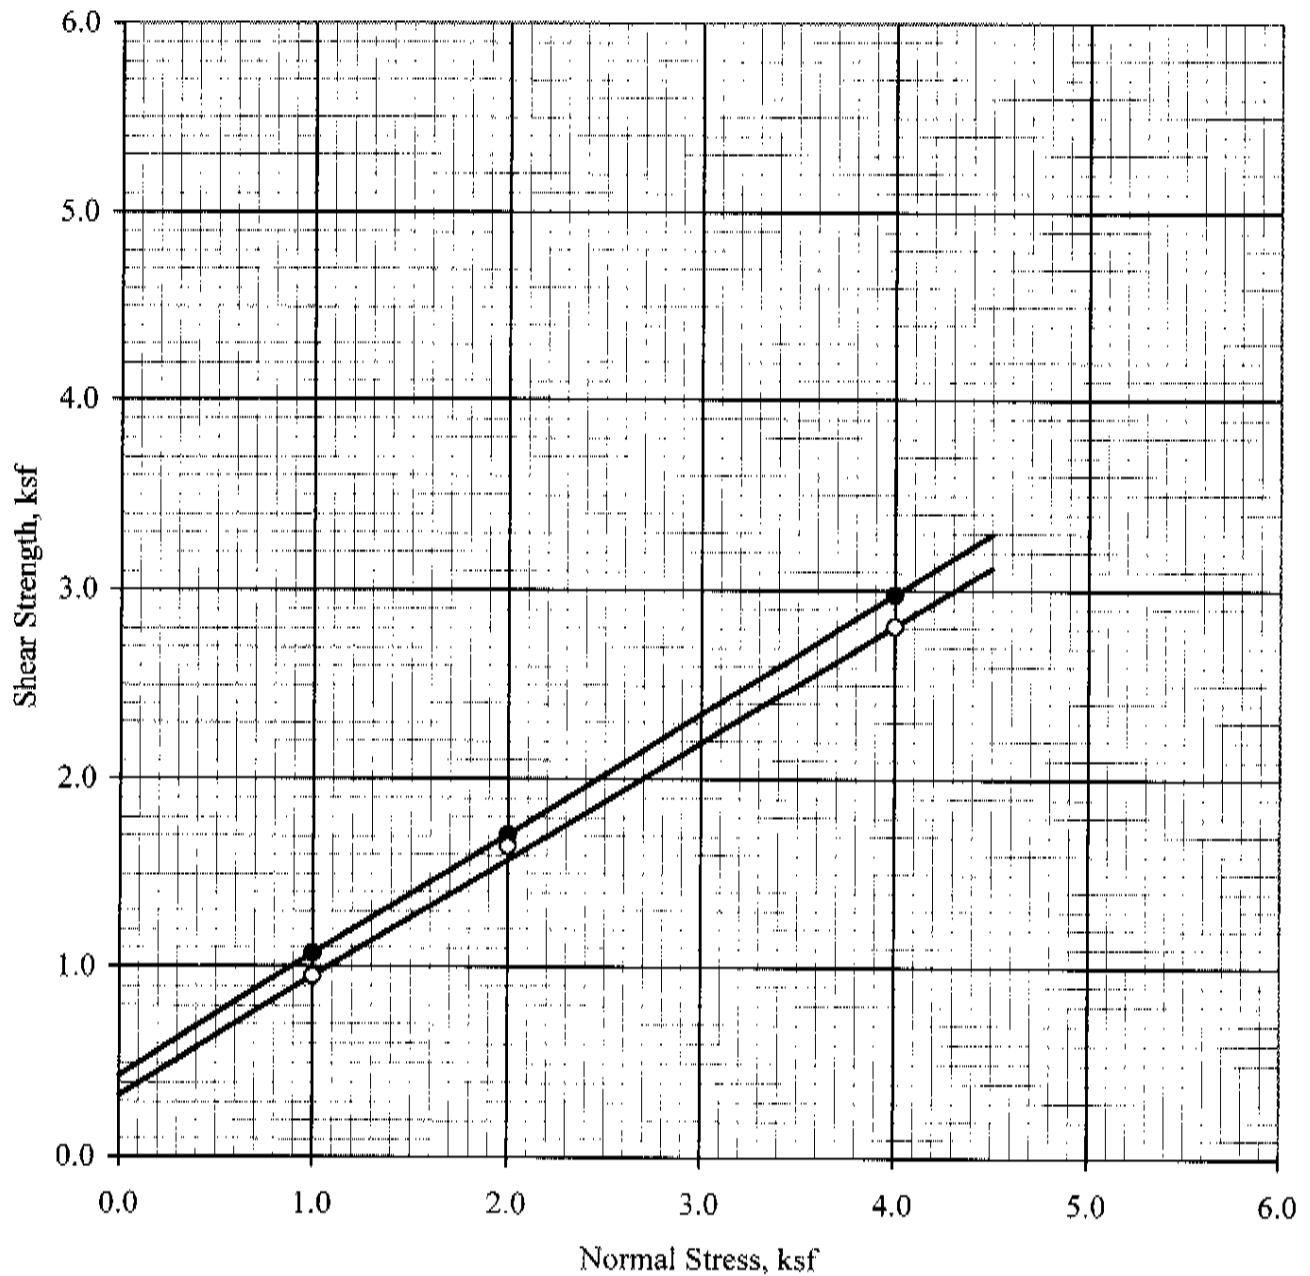
Shear Diagram

- Peak - At Saturation Moisture Content C = 430 psf $\phi = 32^\circ$
- Ultimate - At Saturation Moisture Content C = 320 psf $\phi = 31.5^\circ$

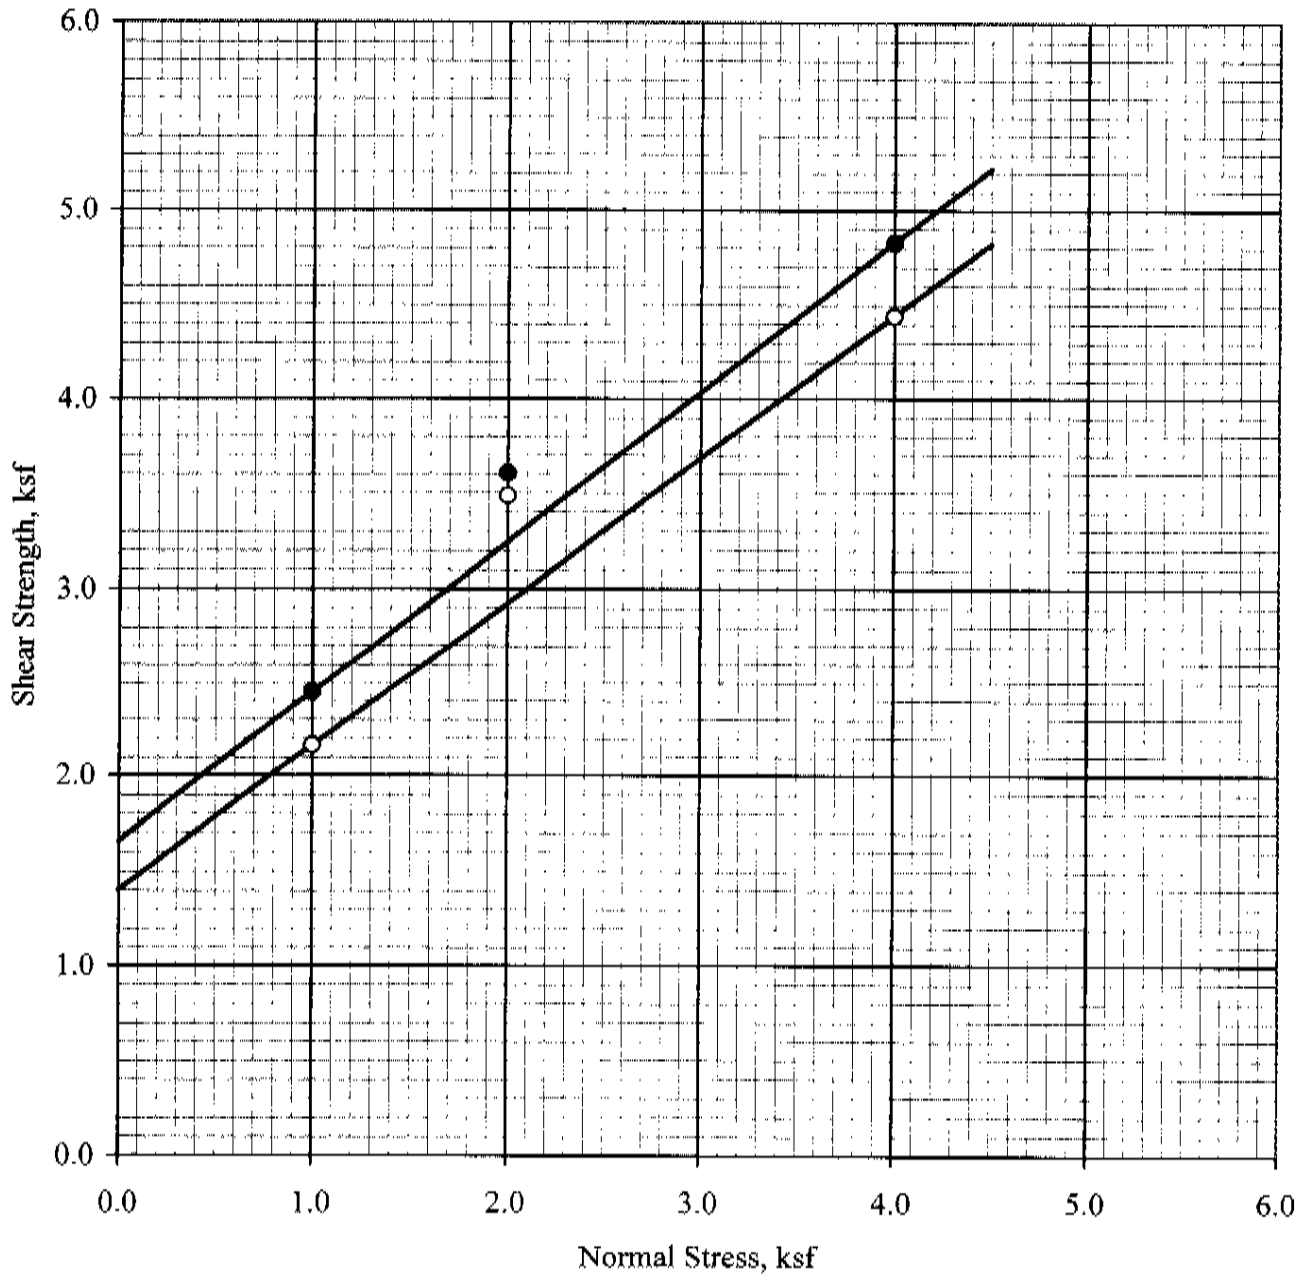
Shear Diagram

- Peak - At Saturation Moisture Content $C = 1650 \text{ psf}$ $\phi = 38^\circ$
- Ultimate - At Saturation Moisture Content $C = 1400 \text{ psf}$ $\phi = 37^\circ$

Field Dry Density = 154 pcf
 Field Moisture Content = 1 %
 Saturation Moisture Content = 3 %

Sample: Bulk
 Depth: ---
 Description: Light gray sandstone

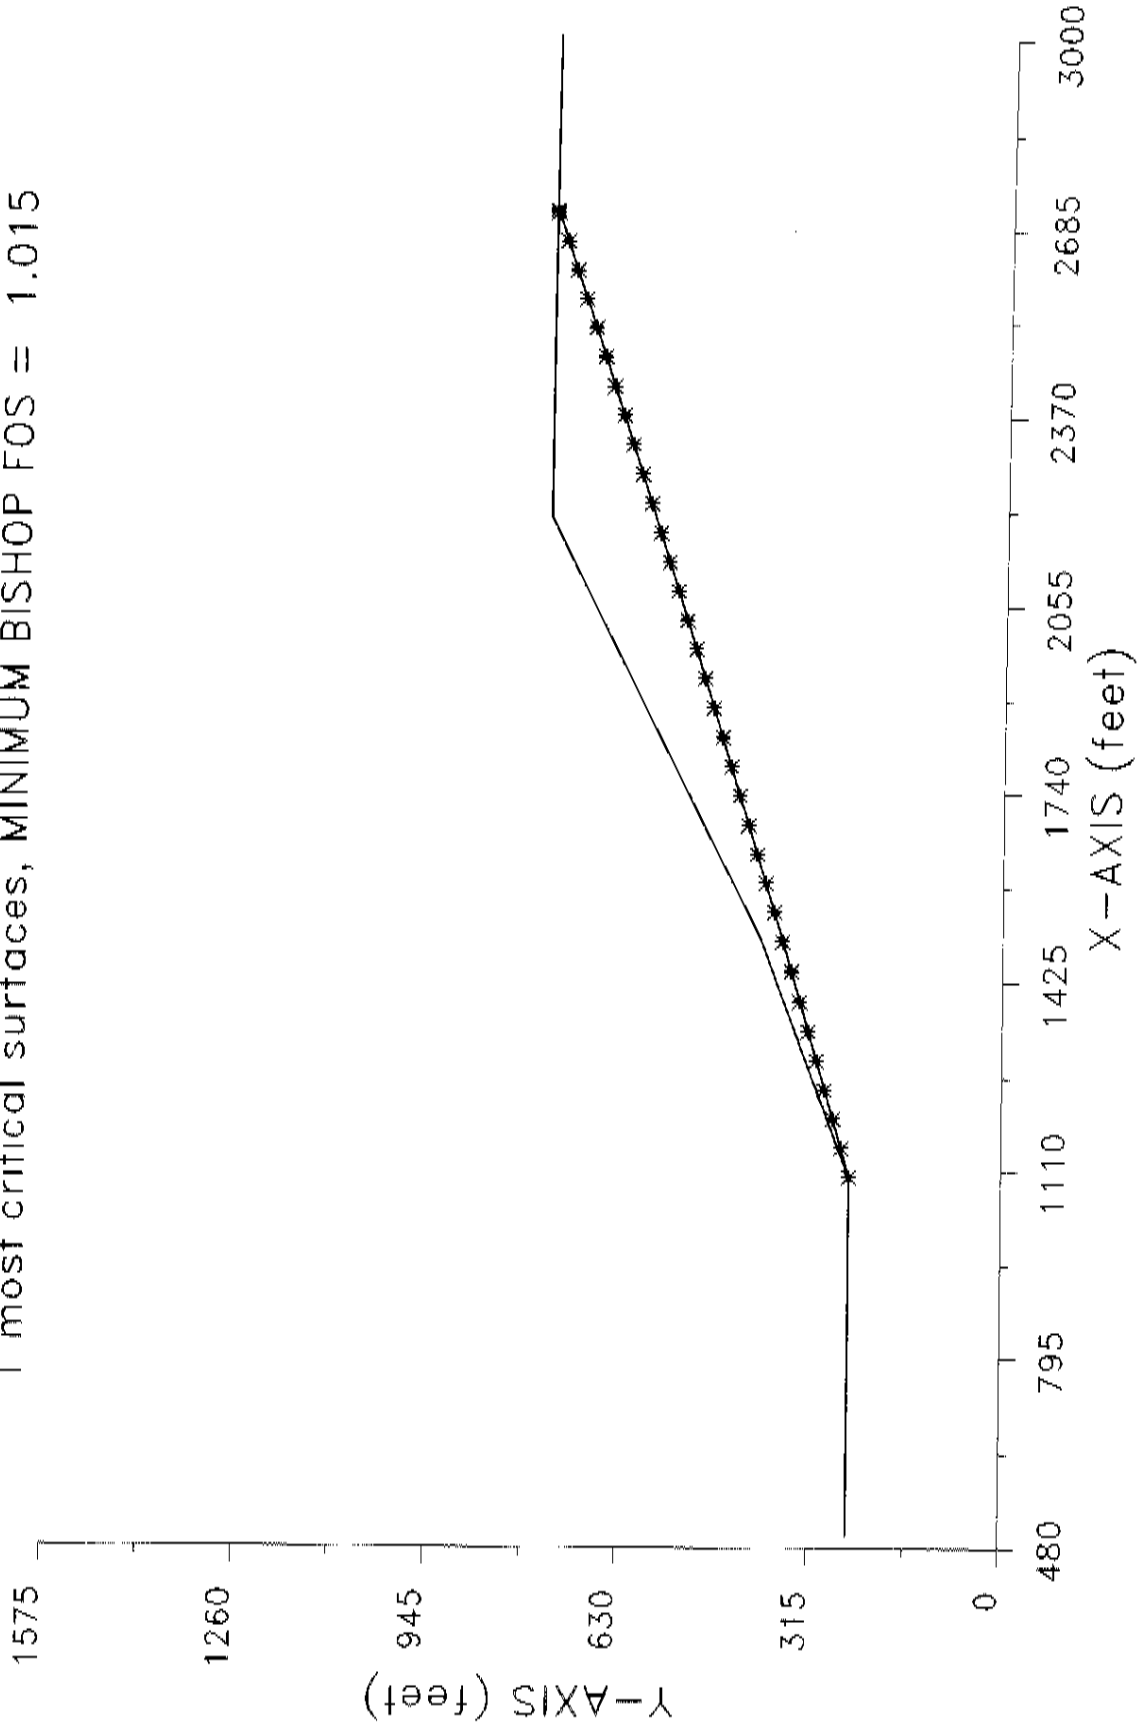
CY4984A1 8-12-** 11:18

DBK/Wetten/15/Circular/Static
1 most critical surfaces, MINIMUM BISHOP FOS = 1.015

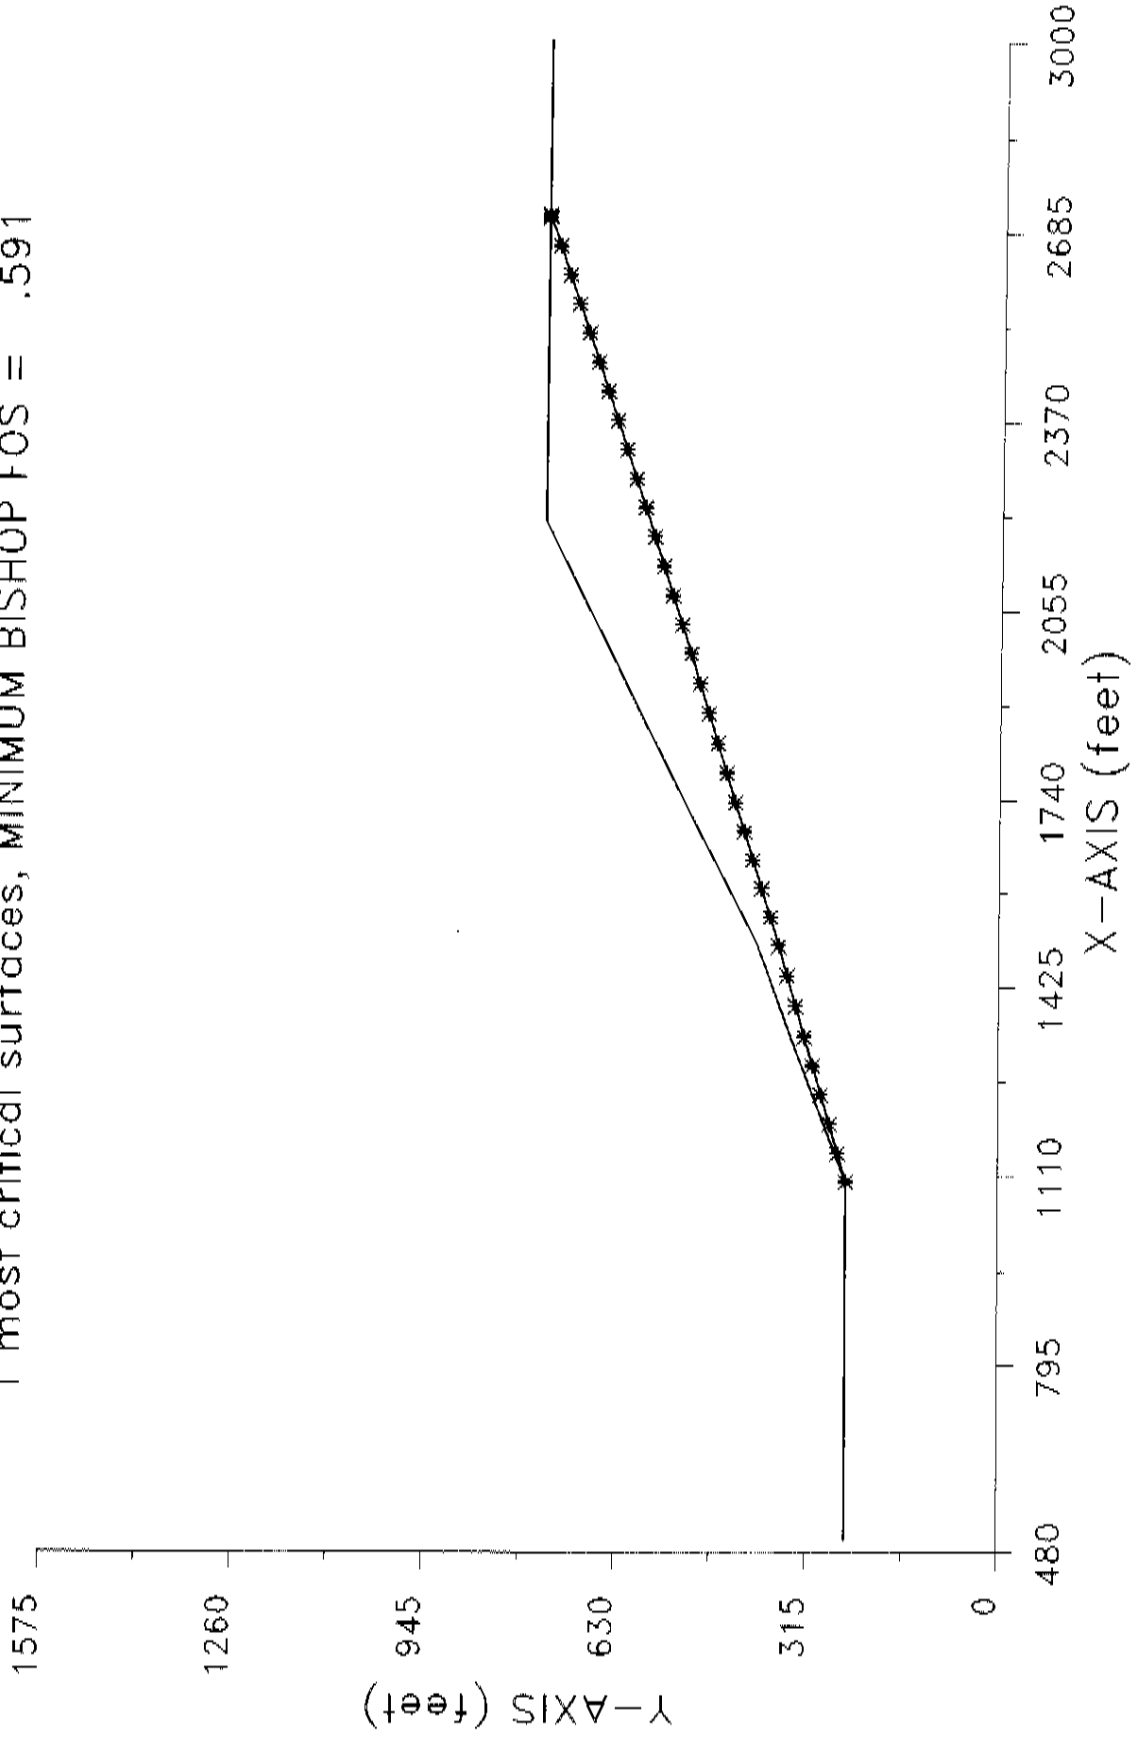
CY4984A2 8-12-** 11:16

DBK/Wetten/15/Circular/Seismic
1 most critical surfaces, MINIMUM BISHOP FOS = .591

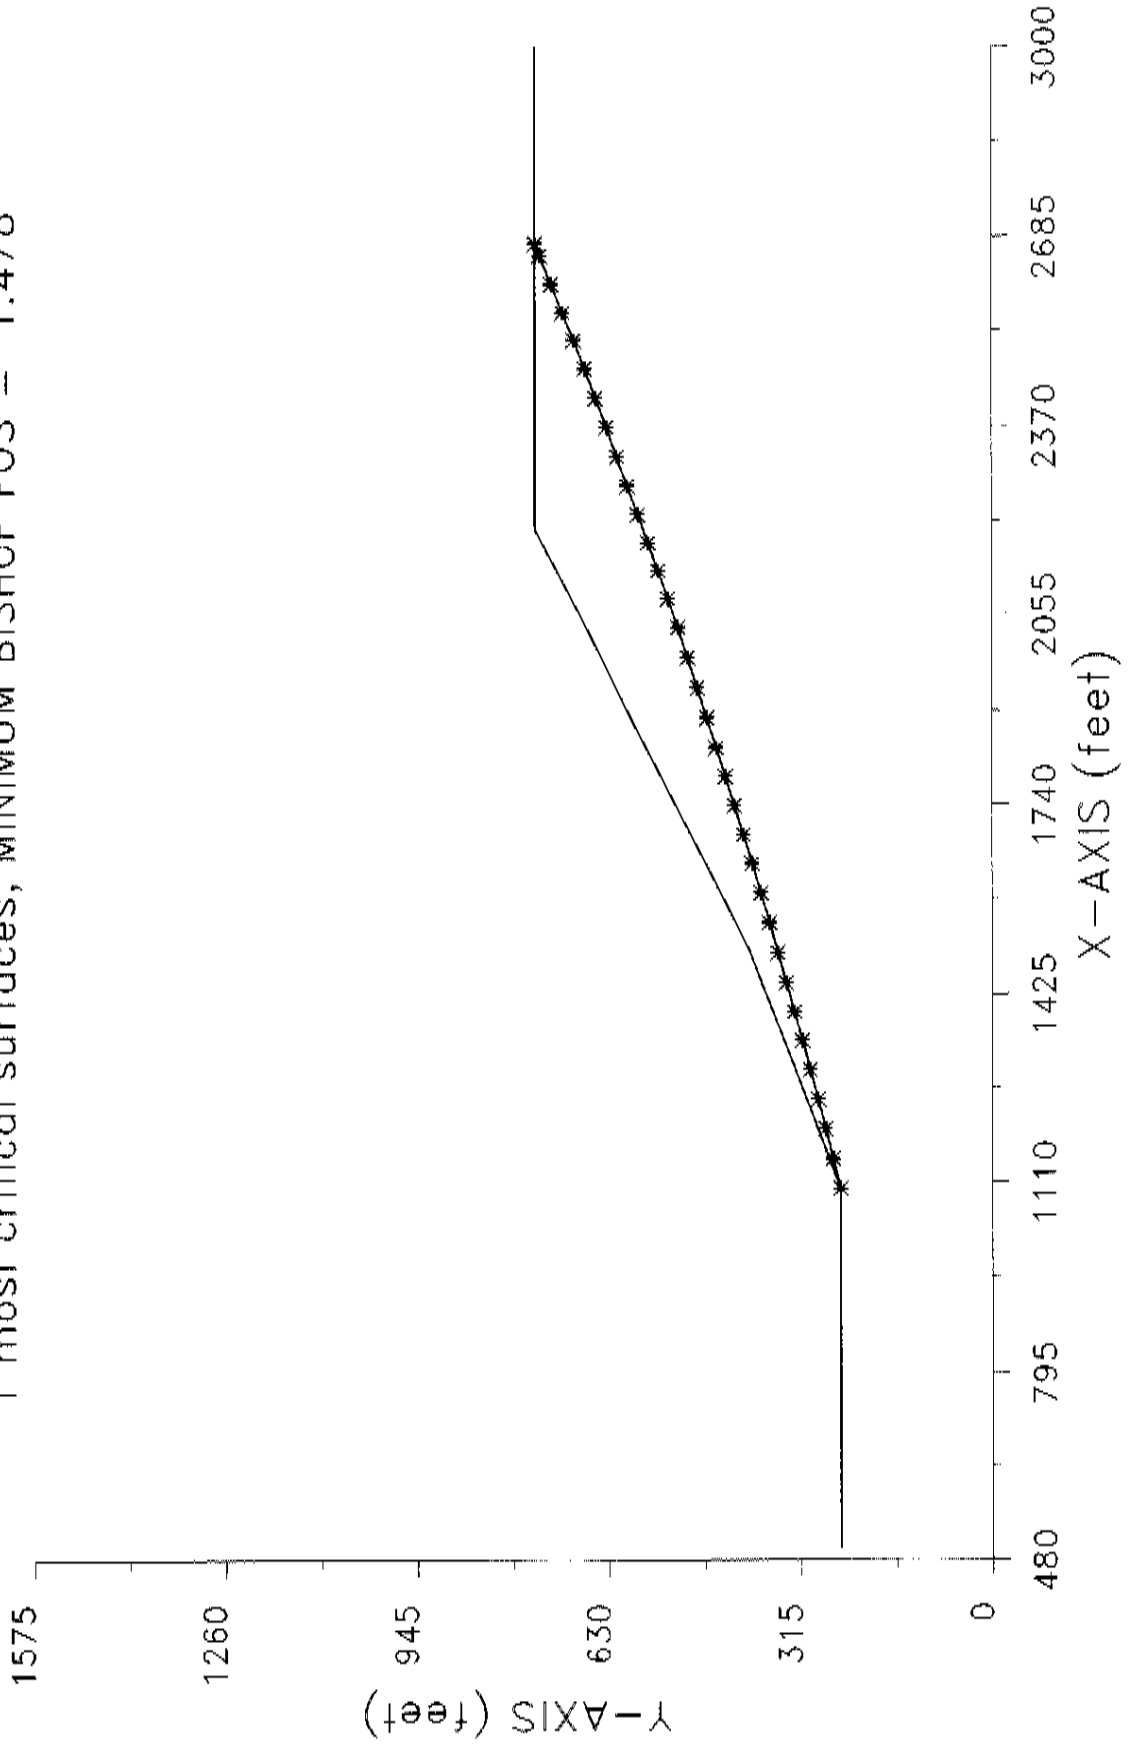
DBK/Wetten/15/Circular/Static
1 most critical surfaces, MINIMUM BISHOP FOS = 1.478

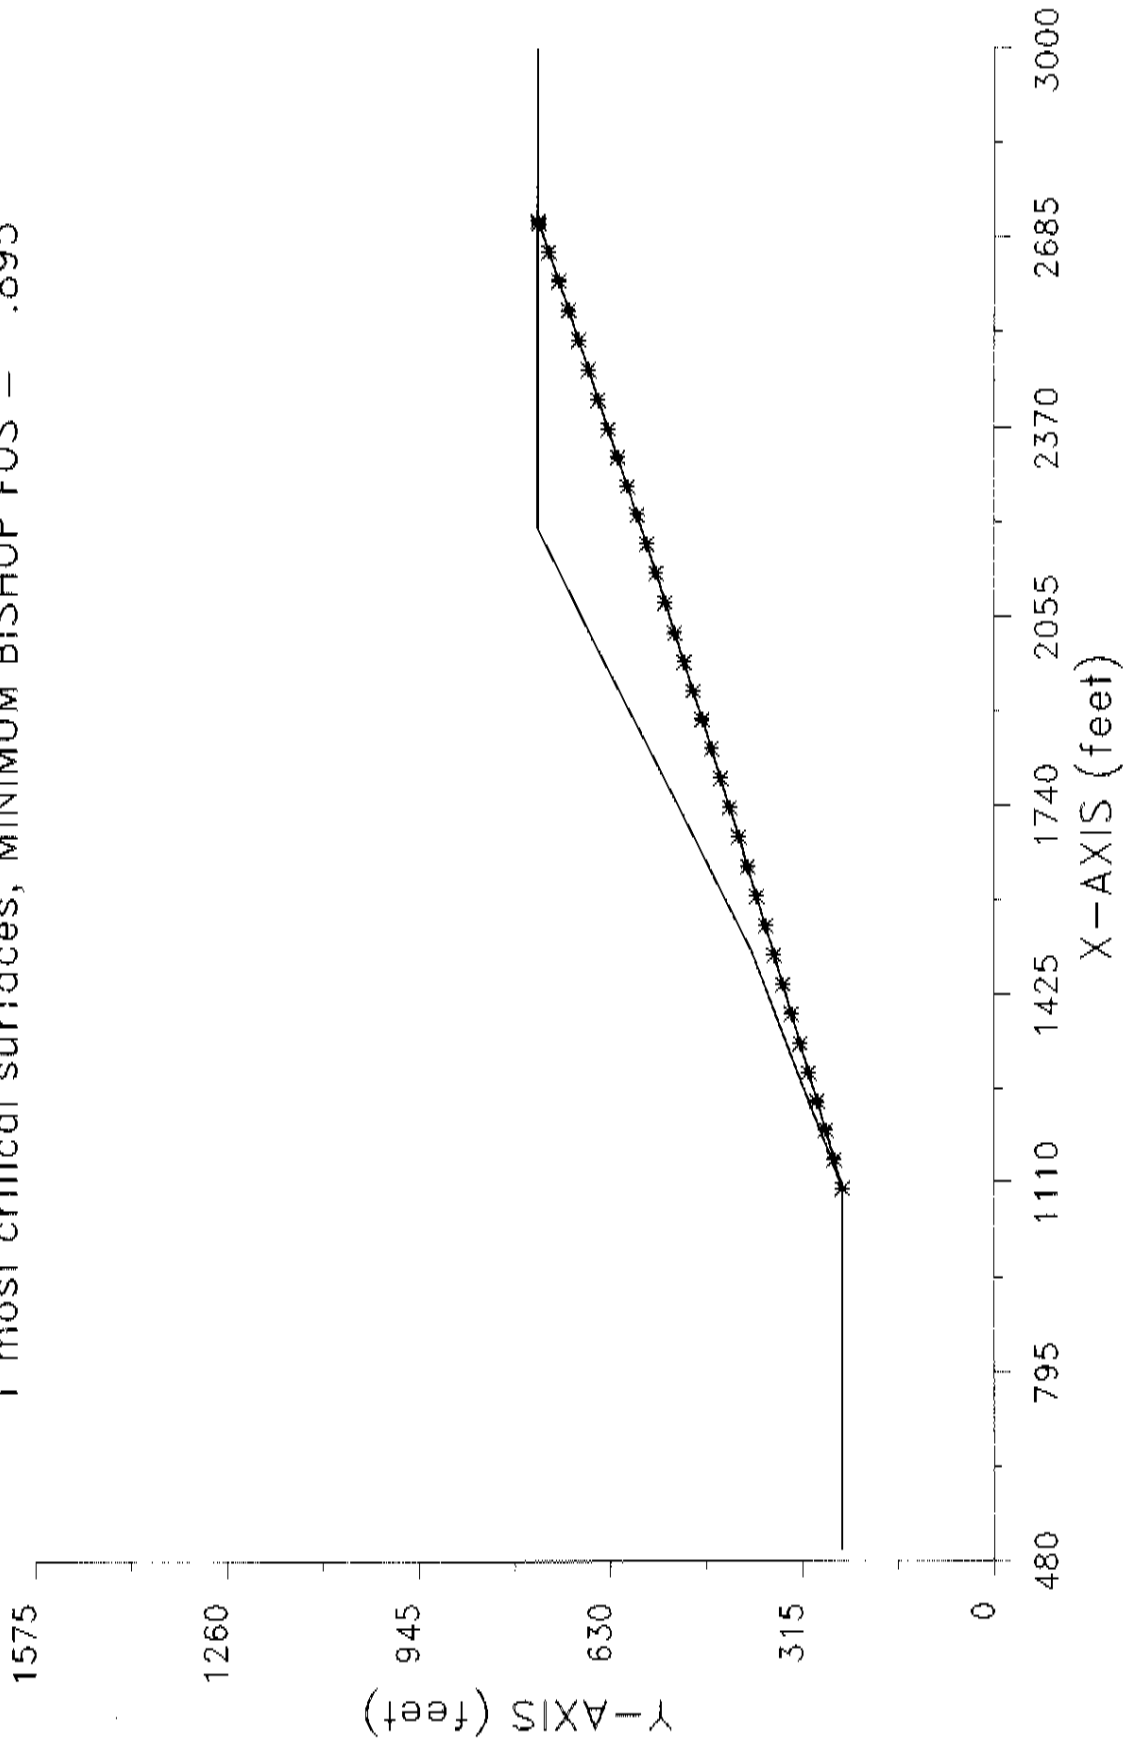
CY4984B2 8-12-** 11:19

DBK/Wetten/15/Circular/Seismic/M2
1 most critical surfaces, MINIMUM BISHOP FOS = .895

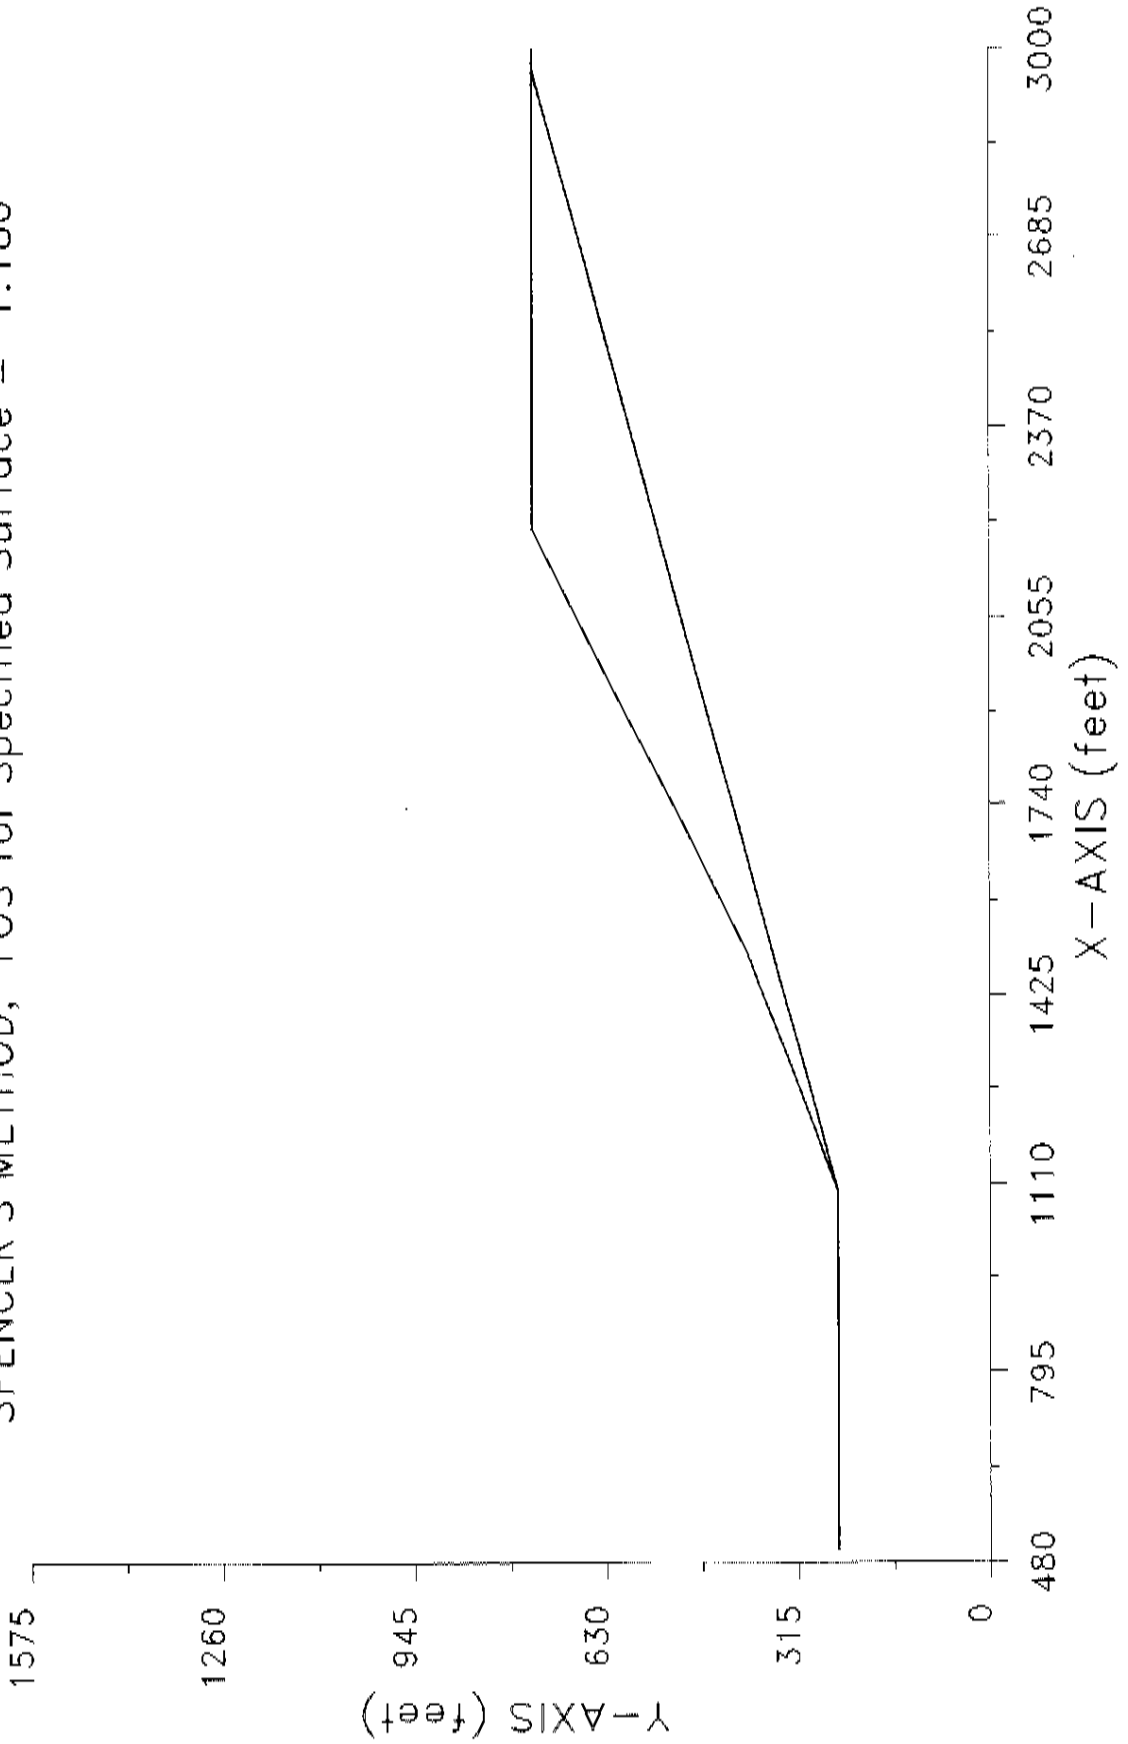
CY4984C1 8-12-** 11:39

DBK/Wetten/15/Planar/Static
SPENCER'S METHOD, FOS for Specified Surface = 1.180

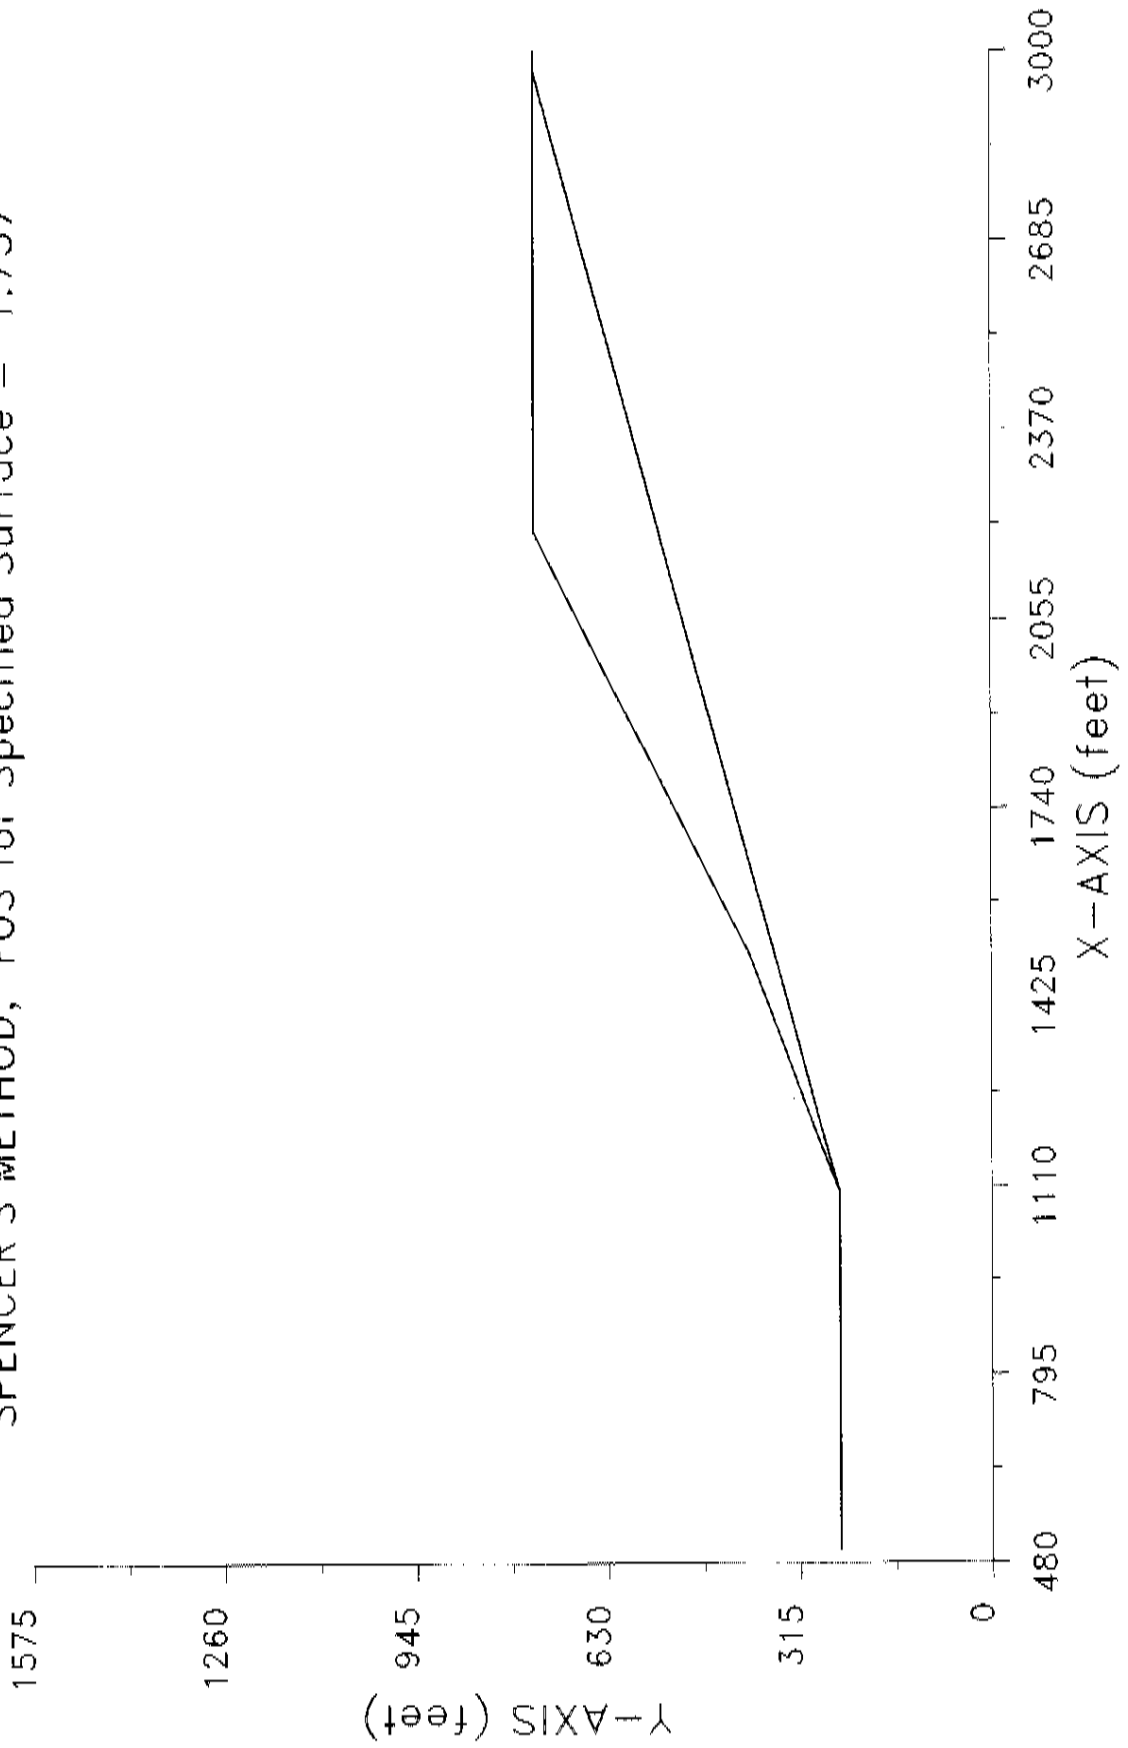
CY4984C3 8-12-** 11:46

DBK/Wetten/15/Planar/Static/M2
SPENCER'S METHOD, FOS for Specified Surface = 1.737

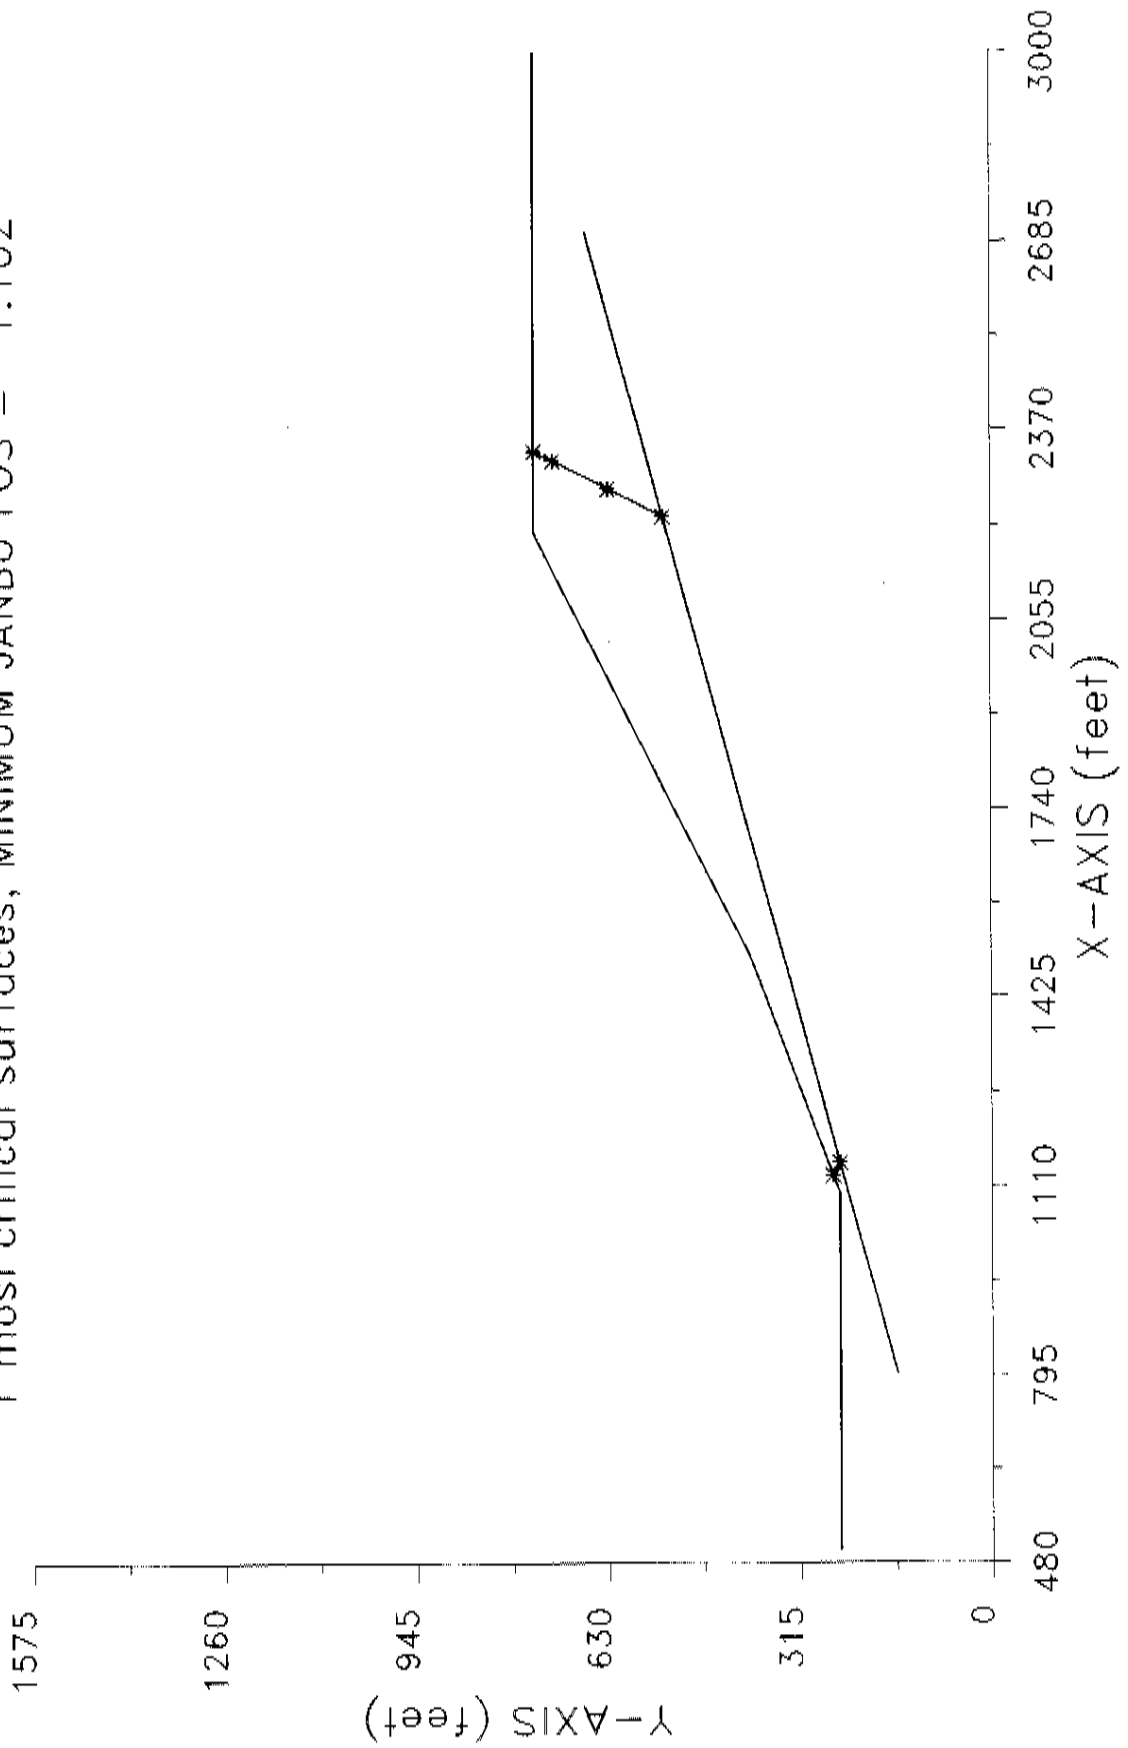
CY4984D1 8-12-** 11:38

DBK/Wetten/15/Planar/Static
1 most critical surfaces, MINIMUM JANBU FOS = 1.102

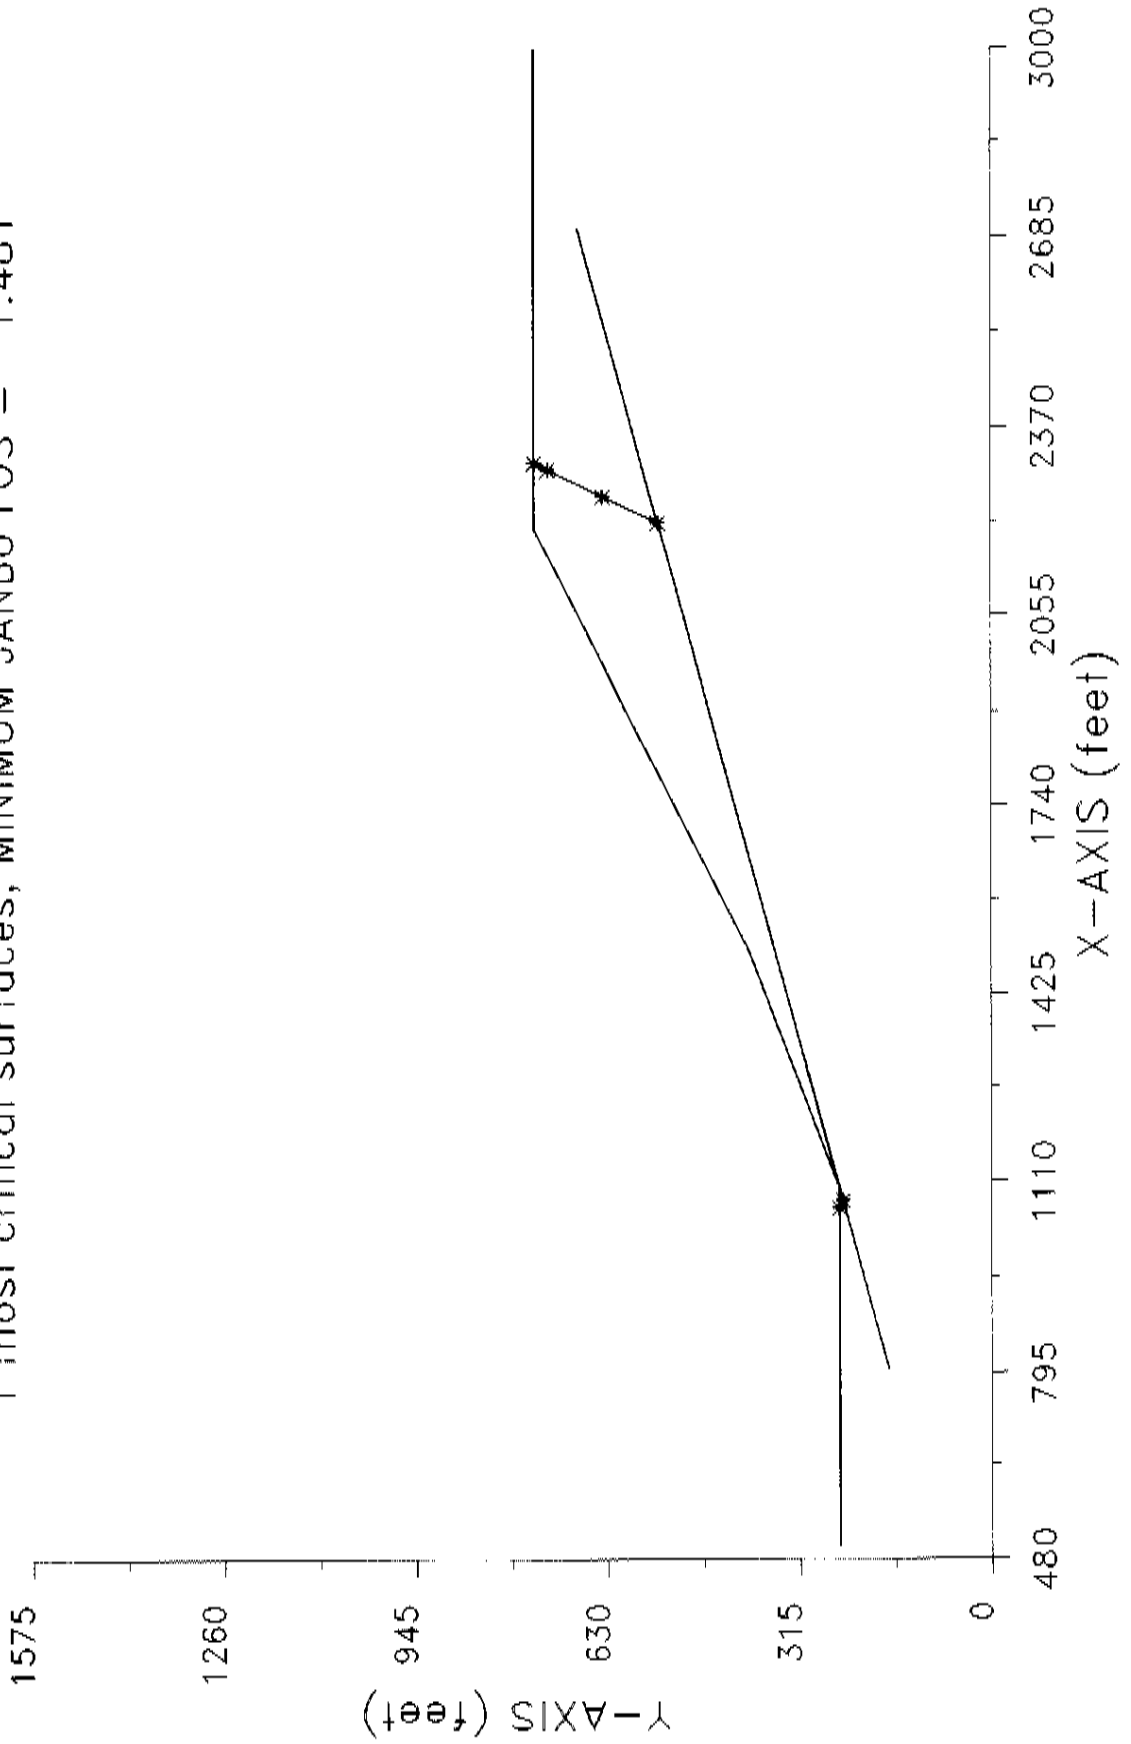
CY4984D3 8-12-** 11:46

DBK/Wetten/15/Planar/Static/M2
1 most critical surfaces, MINIMUM JANBU FOS = 1.481
