Donald B. Kowalewsky
 ENVIRONMENTAL &
 ENGINEERING GEOLOGY

September 20, 2007
 revised October 4, 2007
 Job # 07630A1.001

SUBJECT: Geologic memorandum concerning observations, testing, and analyses of multiple vacant lots at 929 and 939 Fernwood Pacific Drive, Topanga, California

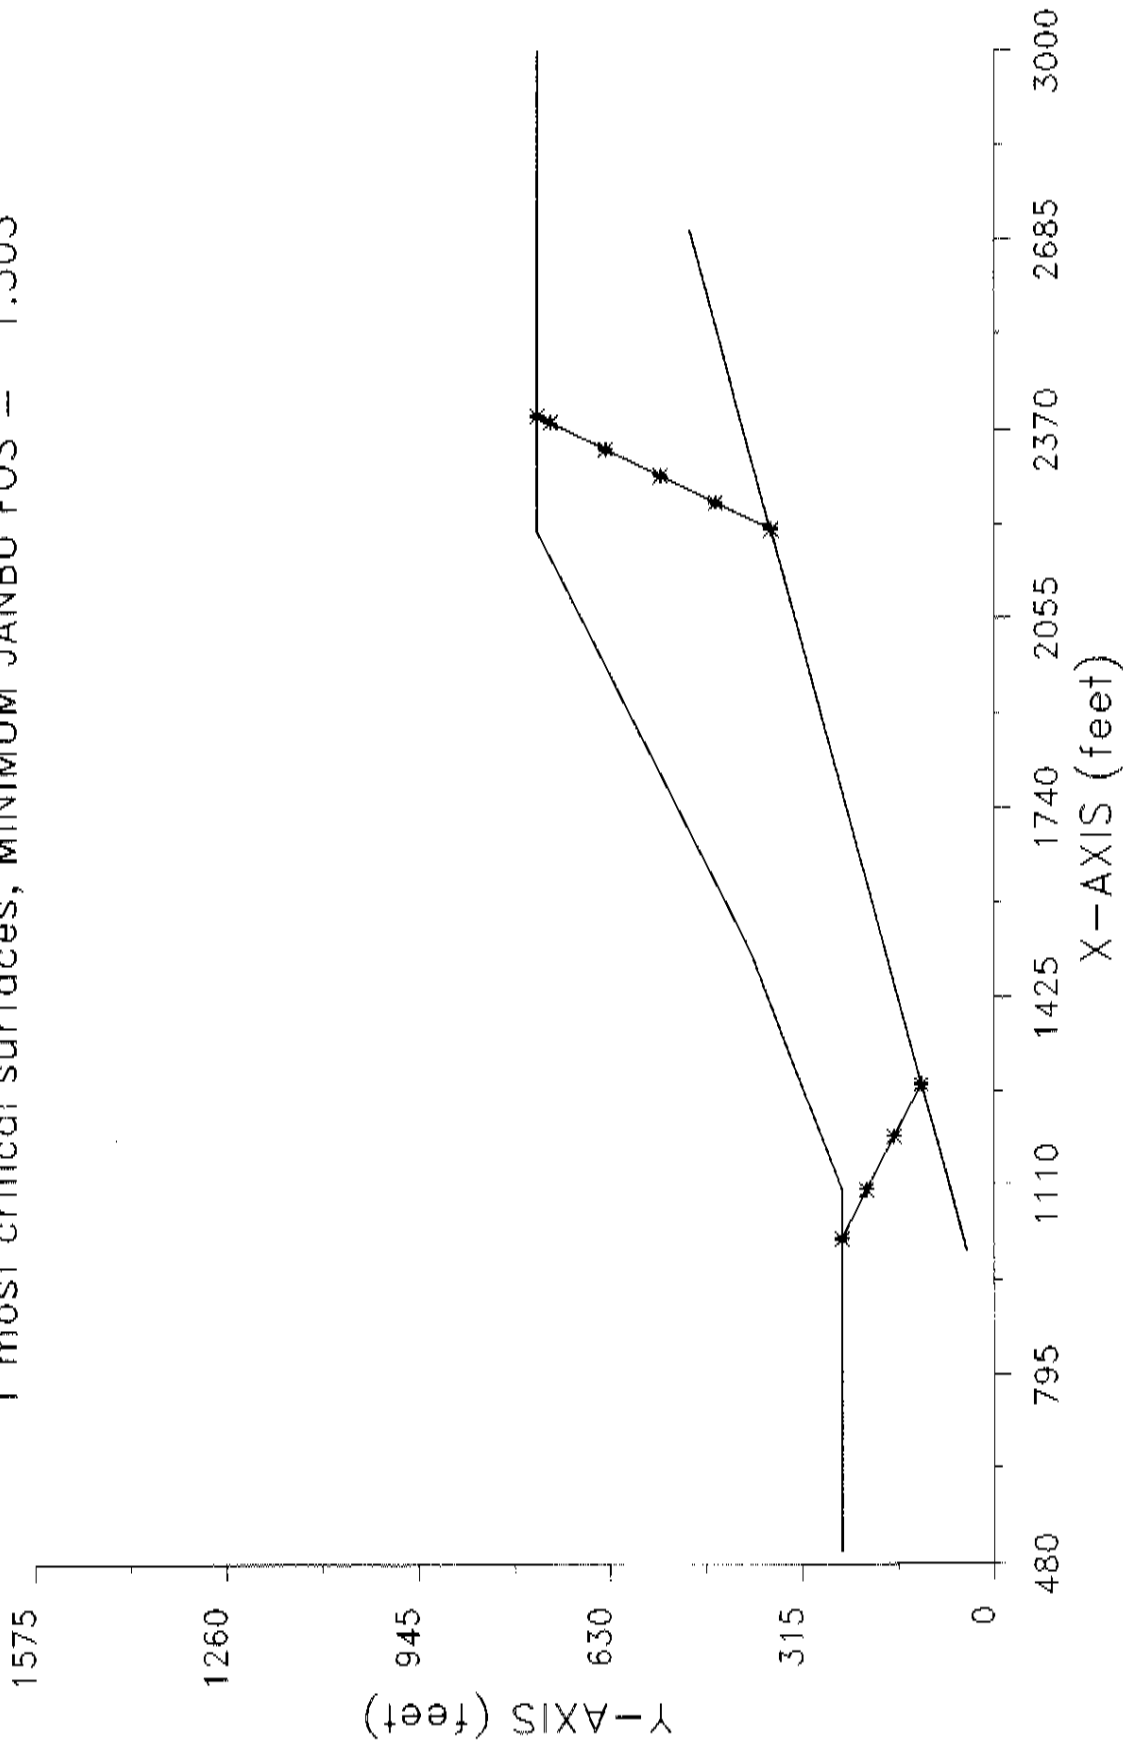
CY4984D5 8-12-** 12:10

DBK/Wetten/15/Planar/Static
1 most critical surfaces, MINIMUM JANBU FOS = 1.503

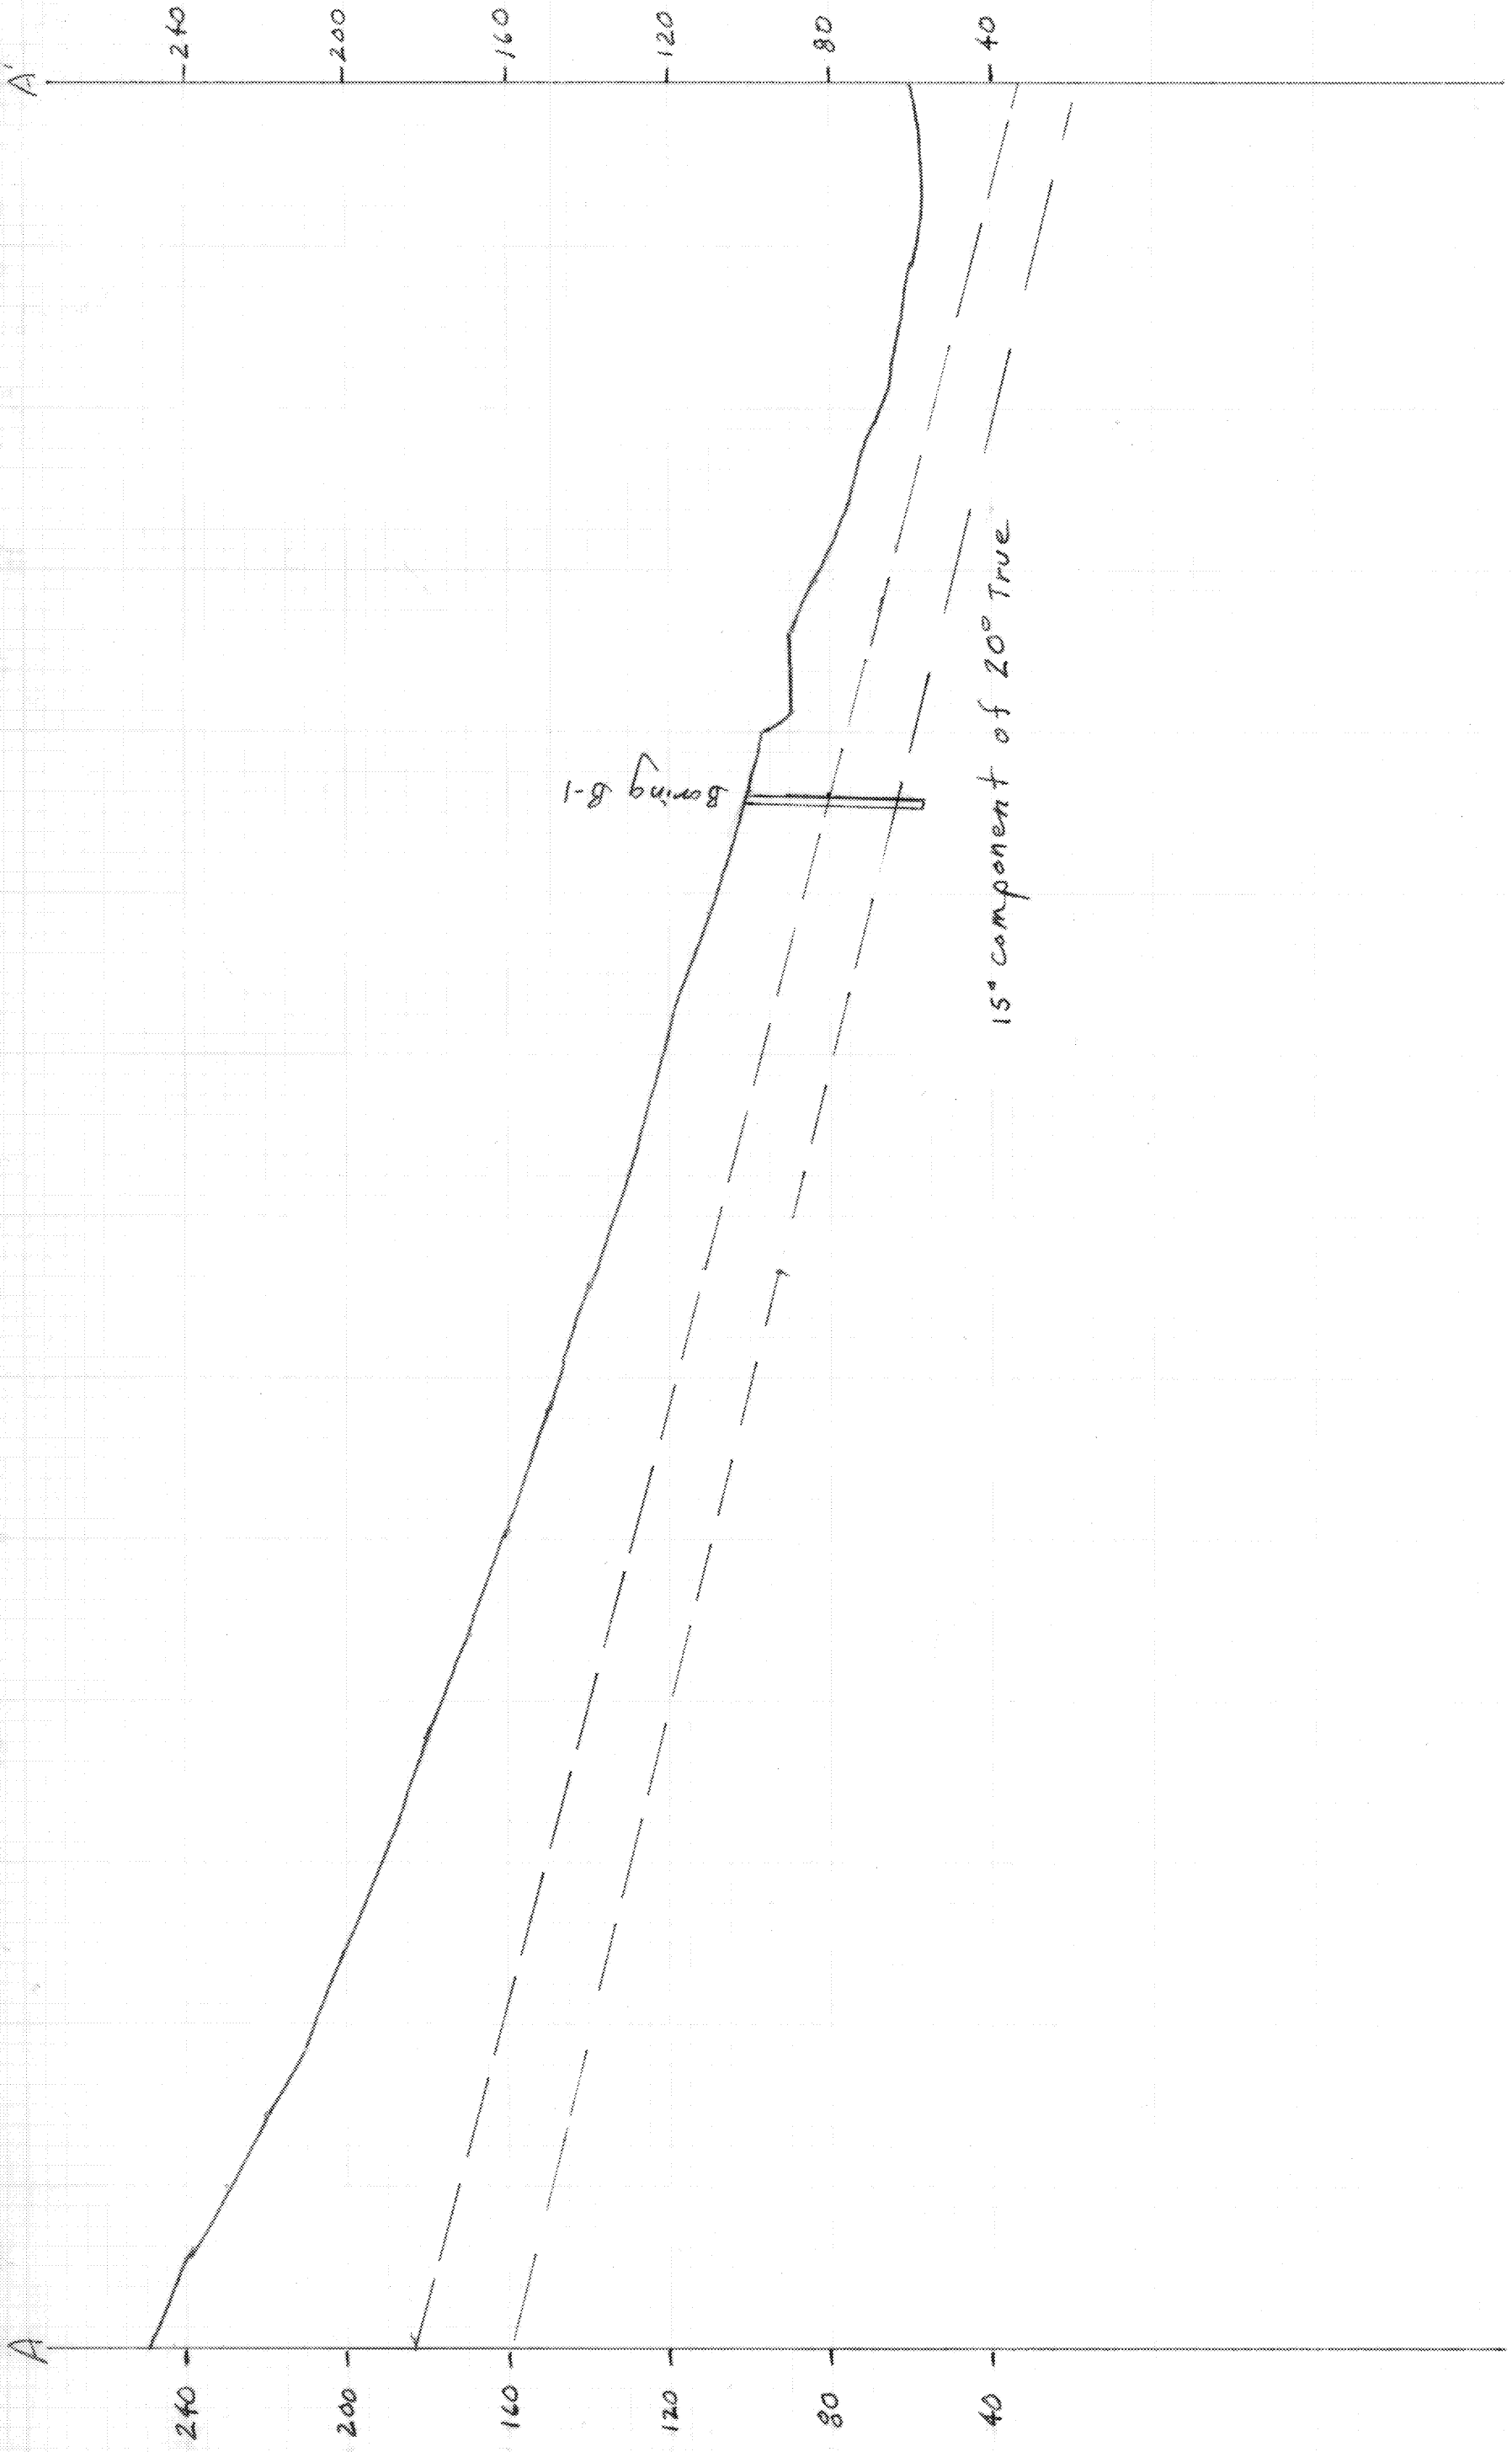
Figure 2
Geologic cross-section

The site topographic map (Figure 1) was utilized to draw a representative geologic cross-section of the slope profile (Figure 2) and underlying geologic conditions based on the logging of the two borings and regional geologic mapping. Based on shear testing of the rock (in order to determine rock strengths), analyses of the slope stability were performed (Appendix C). Those analyses demonstrate that the slope has a substandard safety factor. The amount of resisting force that would be required to bring the safety factor up to the minimum acceptable by the County of Los Angeles for issuance of building permits may not be achievable utilizing soldier piles due to the depth of the potential failure surfaces and the very high forces that would need to be resisted.
